**Main Street Iowa
Proposed Façade Rehabilitation
Former Linda's Fashions
Jefferson, Iowa
Project #12515
April 4, 2016**

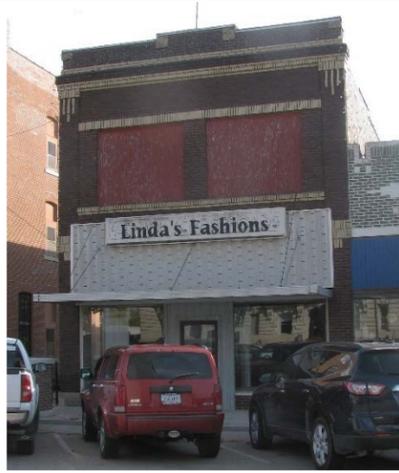
Existing

- >Even though it may not currently appear so, the façade has a good amount of historic integrity and character which can be fairly easily uncovered and capitalized upon.

- >Remove all of the inappropriate siding materials from the upper floor windows and the upper storefront.
- >Restore all of the upper floor windows. The windows shown on the rendering are for illustration purposes only. The existing windows should be restored if possible, replicated if replaced.

- >Restore the transom window above the existing flat canopy. The transom glass shown is a typical tinted glass commonly used on buildings of this age. Any existing transom glass should be used, or at a minimum serve as a guide for any new glass.

- >The existing storefront is a historic copper frame storefront with unique character and style. Even though it is single pane, it should be retained. It is possible to install additional interior glazing to isolate the display windows and minimize the impact of the single pane glass. This secondary glazing should be installed at the rear of the window displays.

- >Before undertaking the more “aesthetic” improvements like the storefront, the basic components of the building (roof, drainage, masonry, etc.) need to be addressed and repaired/replaced as needed.

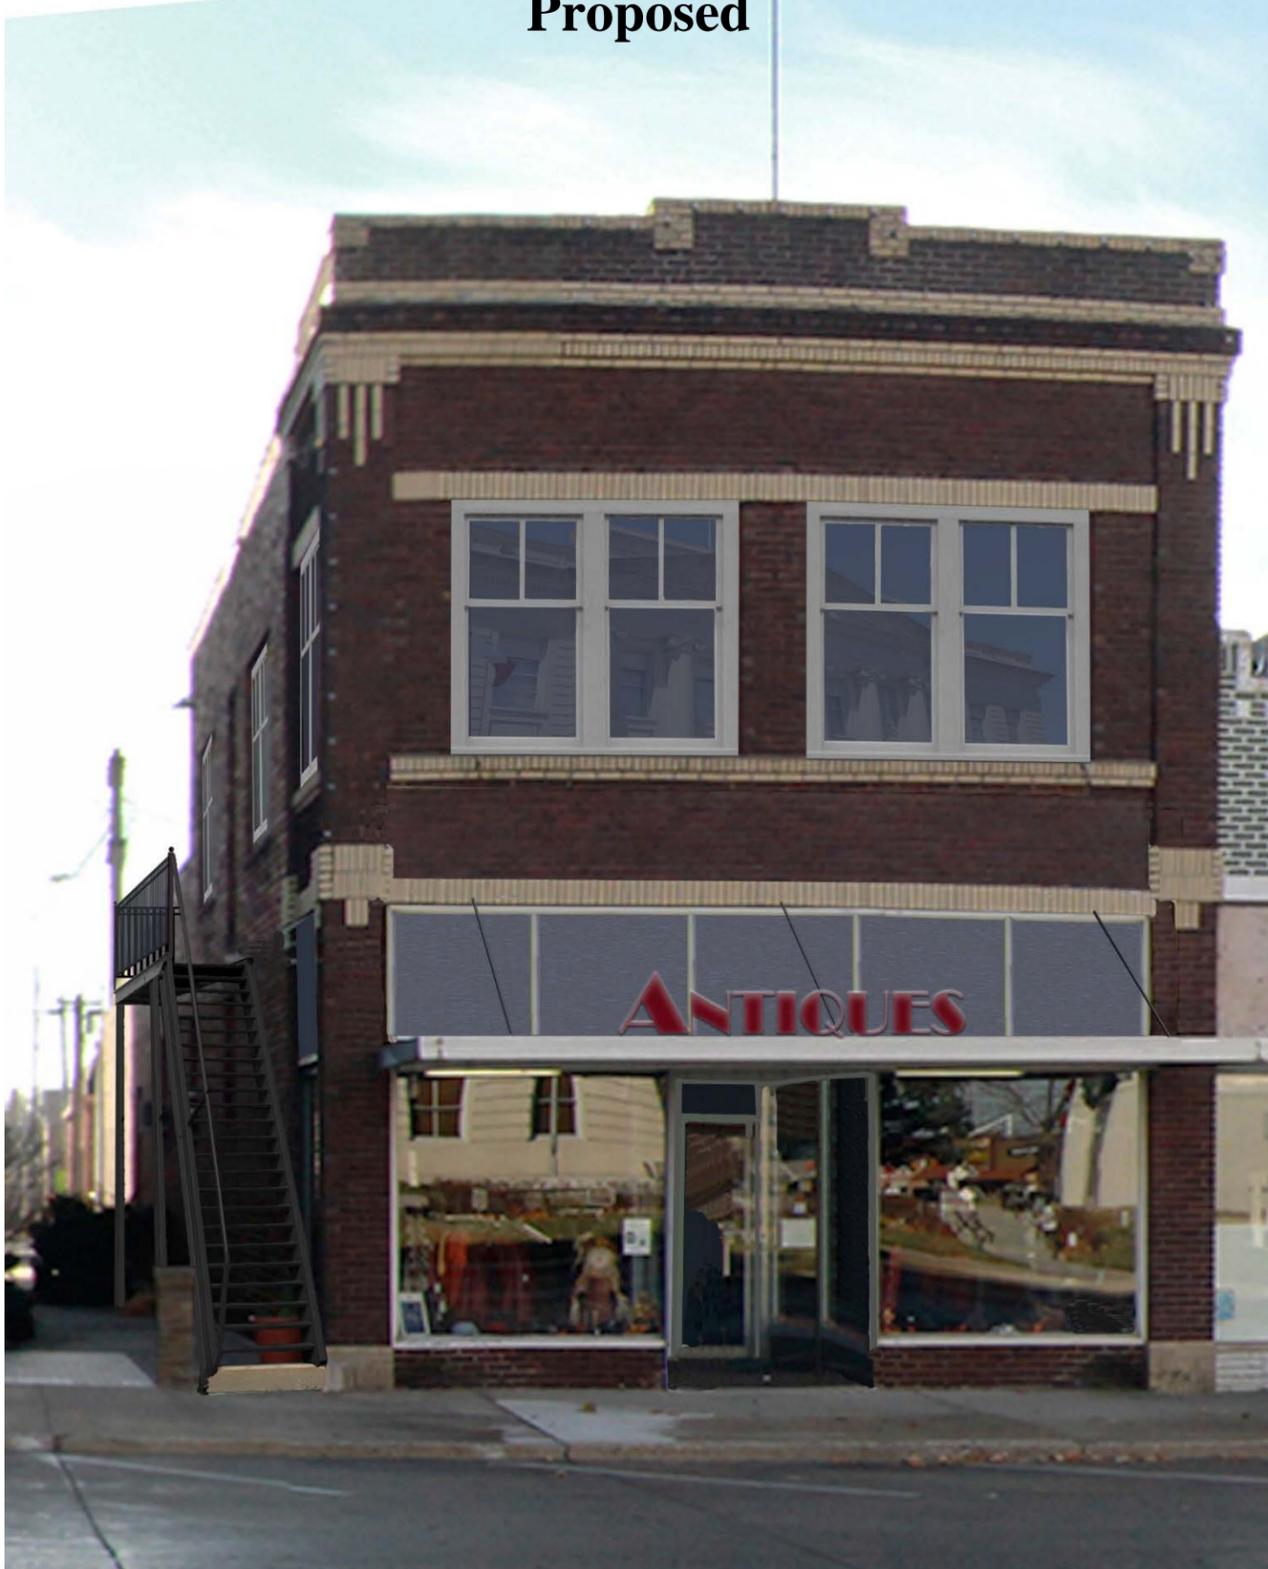
Proposed

- >Install a new sign for the business. The sign shown is individual (internally lit?) letters attached to the front edge of the canopy.
- >Install a new exterior stair and landing along the alley to access the upper floor. Ideally an interior stair (at the rear?) should be created too to make a more desirable entrance to the upper floor. If possible, the rear should incorporate a garage space and the stairs could lead from there.
